SECTION 1. EXECUTIVE DIGEST

1.1 BACKGROUND

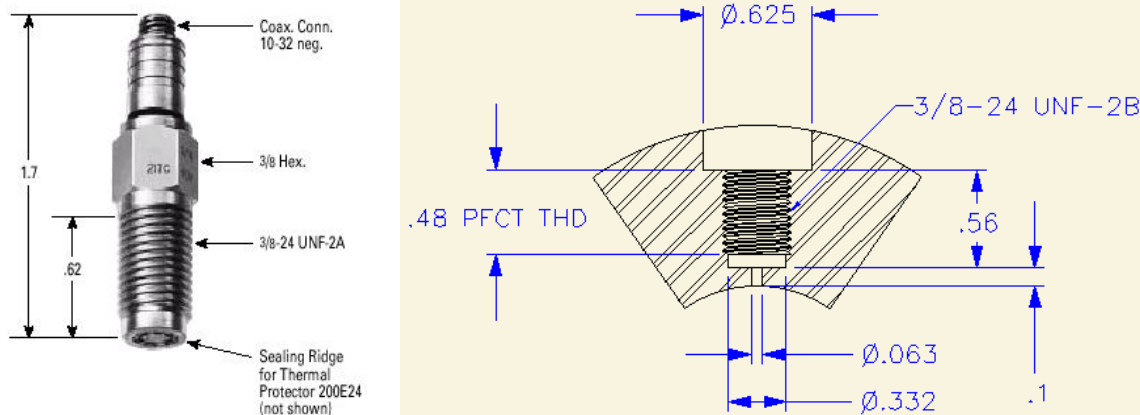
Figures 4a and 4b. Kistler Model 217C Ballistic Pressure Transducer, dimensionally identical to Kistler Model 617C, and the recommended pressure port.

Despite use of the recommended pressure port, Helmholtz resonance was present which forced the ballistics technician to subjectively estimate the actual peak pressure.

Filtering was tried at four different levels (20 KHz, 10 KHz, 5 KHz, and 1 KHz) to reduce the effect of “ringing” until an optimum filter level was found at 5 KHz. All subsequent testing was accomplished using a 5 KHz filtered signal to report peak chamber pressure. Based on the success with this approach to eliminating Helmholtz Resonance, a 5 KHz filter will be used in subsequent 25mm testing with the Kistler Model 617 Transducer.

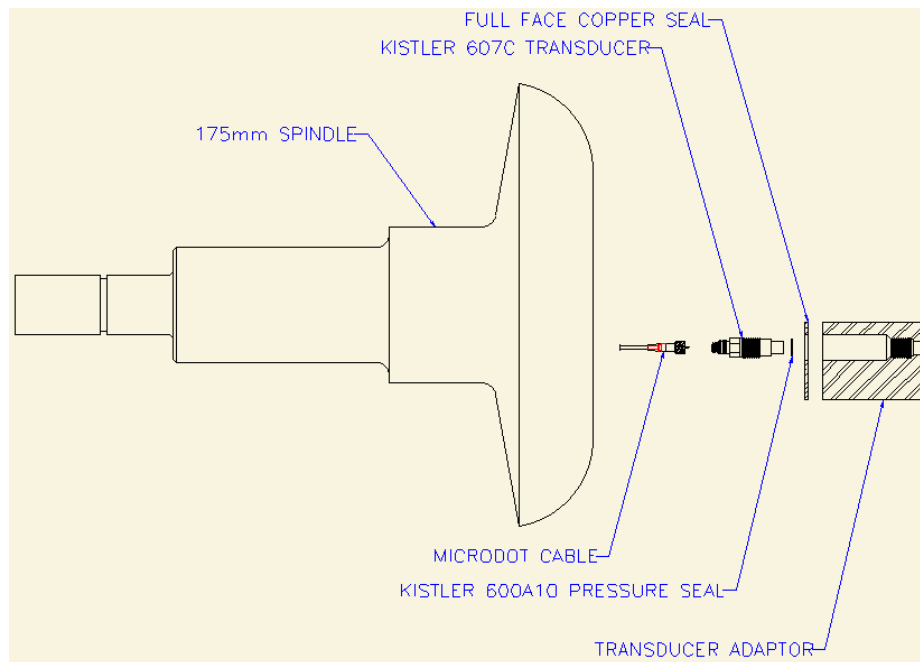
Figure 15. General arrangement of transducer adaptor, pressure seals, and transducer for measuring rear pressure in 175mm cannon. Not shown are the two 1/4-28 socket head cap screws hand tightened to assemble the adaptor to the spindle.

The transducer adaptor design can be improved by machining existing hardware or by fabrication of new adaptor body (preferred). First, the full face copper seal needs to be reduced in size to permit crushing and intimate contact following application of screw torque. This can be done by confining sealing to the diameter immediately around the transducer cavity. The seal itself would then become approximately $\varnothing.625$ inch. Matching 150° beveled surfaces would then be machined into the seal and corresponding sealing surfaces of the spindle and adaptor providing maximum compression of the seal during installation and especially during cannon firing. Specifying a 14 lb-ft torque level for 1/4-28 hardened alloy steel socket head cap screws would be required. Improved compression of the pressure seal would be obtained by adding a third screw to the adaptor assembly; the screws would be equally spaced for proper distribution of the clamping force during torque application.
